**NORWAY/UNITED STATES DESIGN PROTECTIVE
AIRCRAFT SHELTER (PAS) QUANTITY-DISTANCE
PROGRAM 1/3-SCALE TEST SERIES**

**Volume I of V
PAS 1-4 Summary**

Final Report

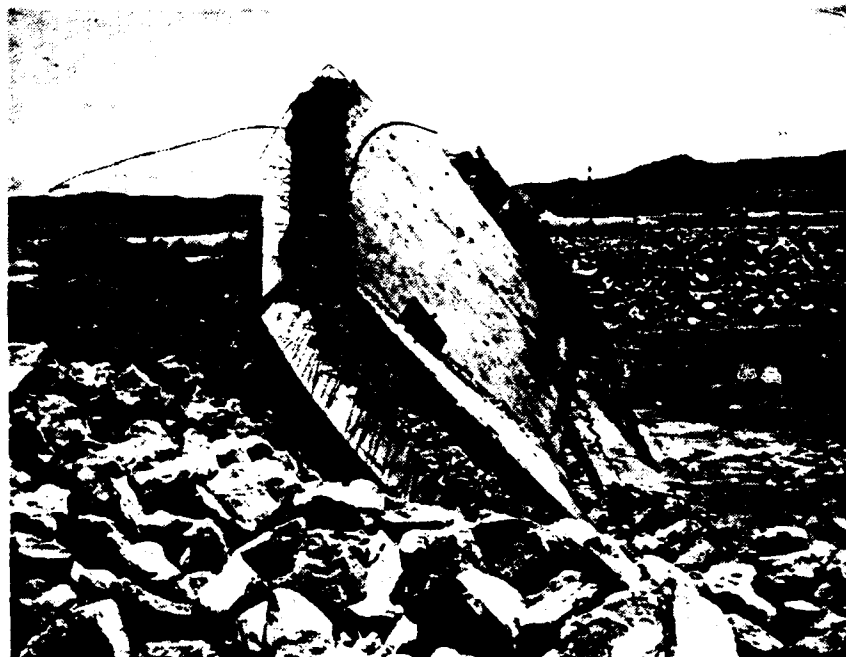
Figure 248. Top edge of backwall, PAS-4.

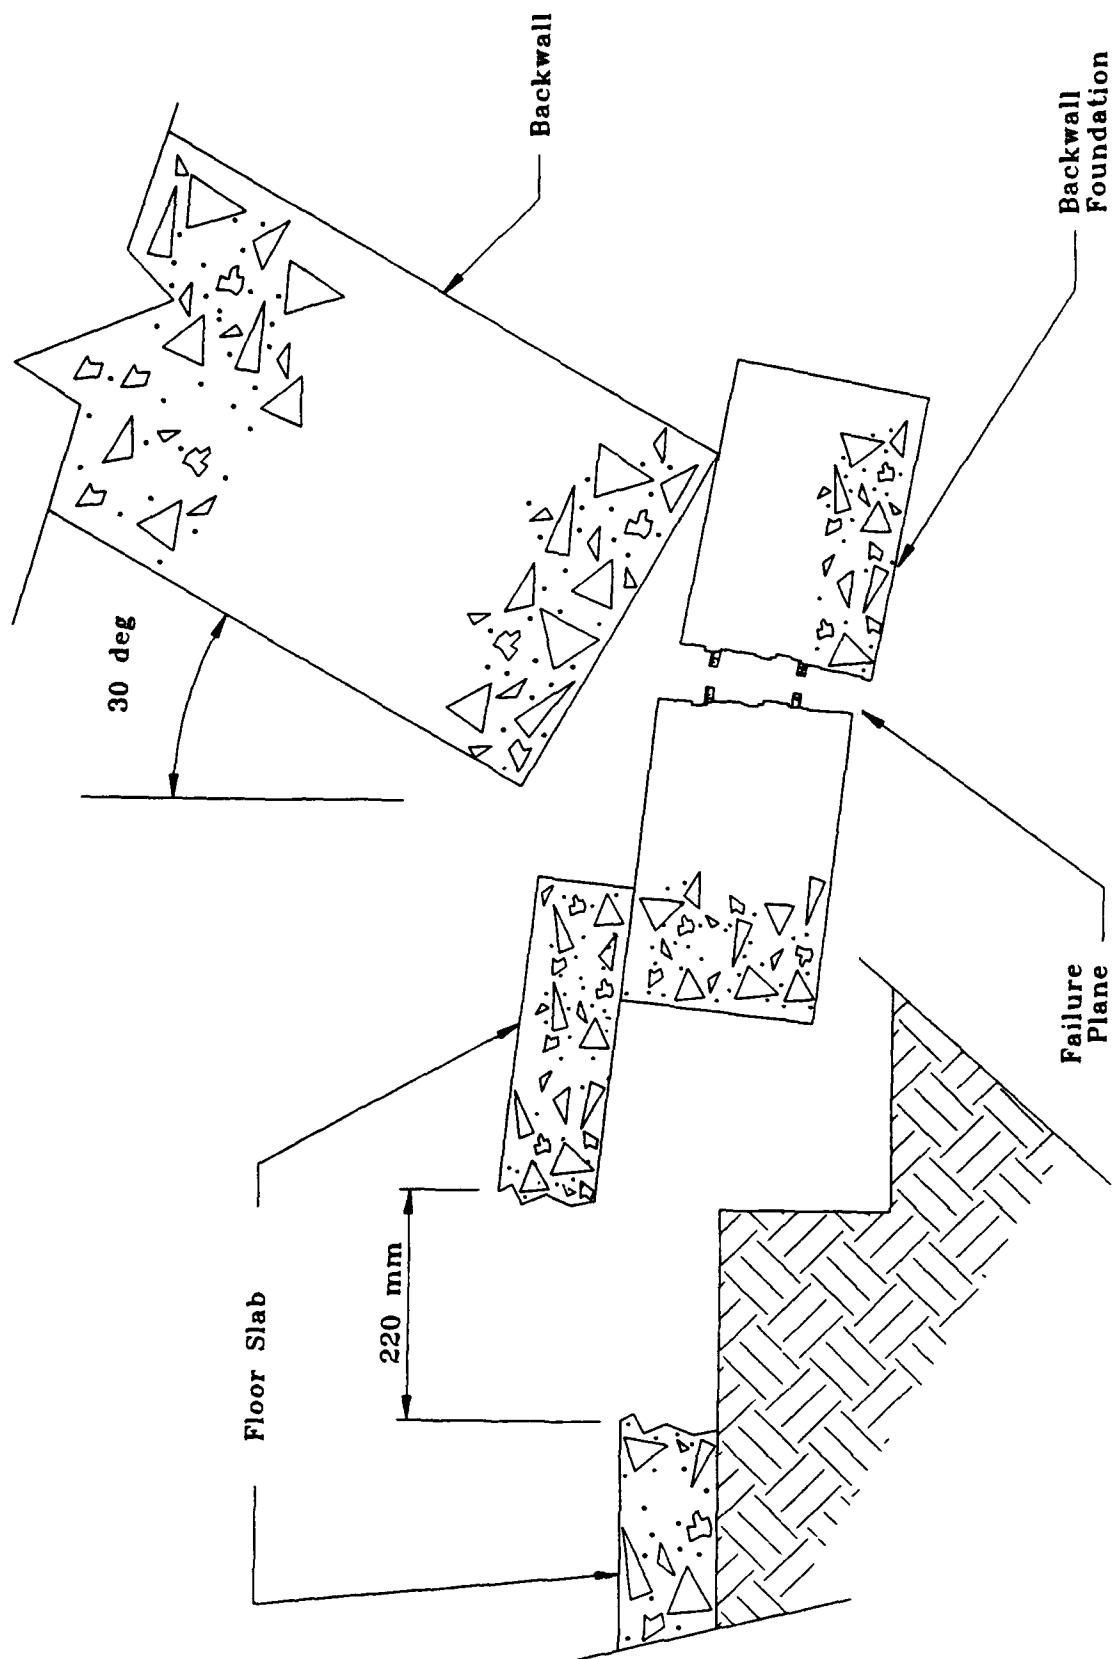
Figure 250. Section: Breakup pattern of backwall foundation, PAS-4.

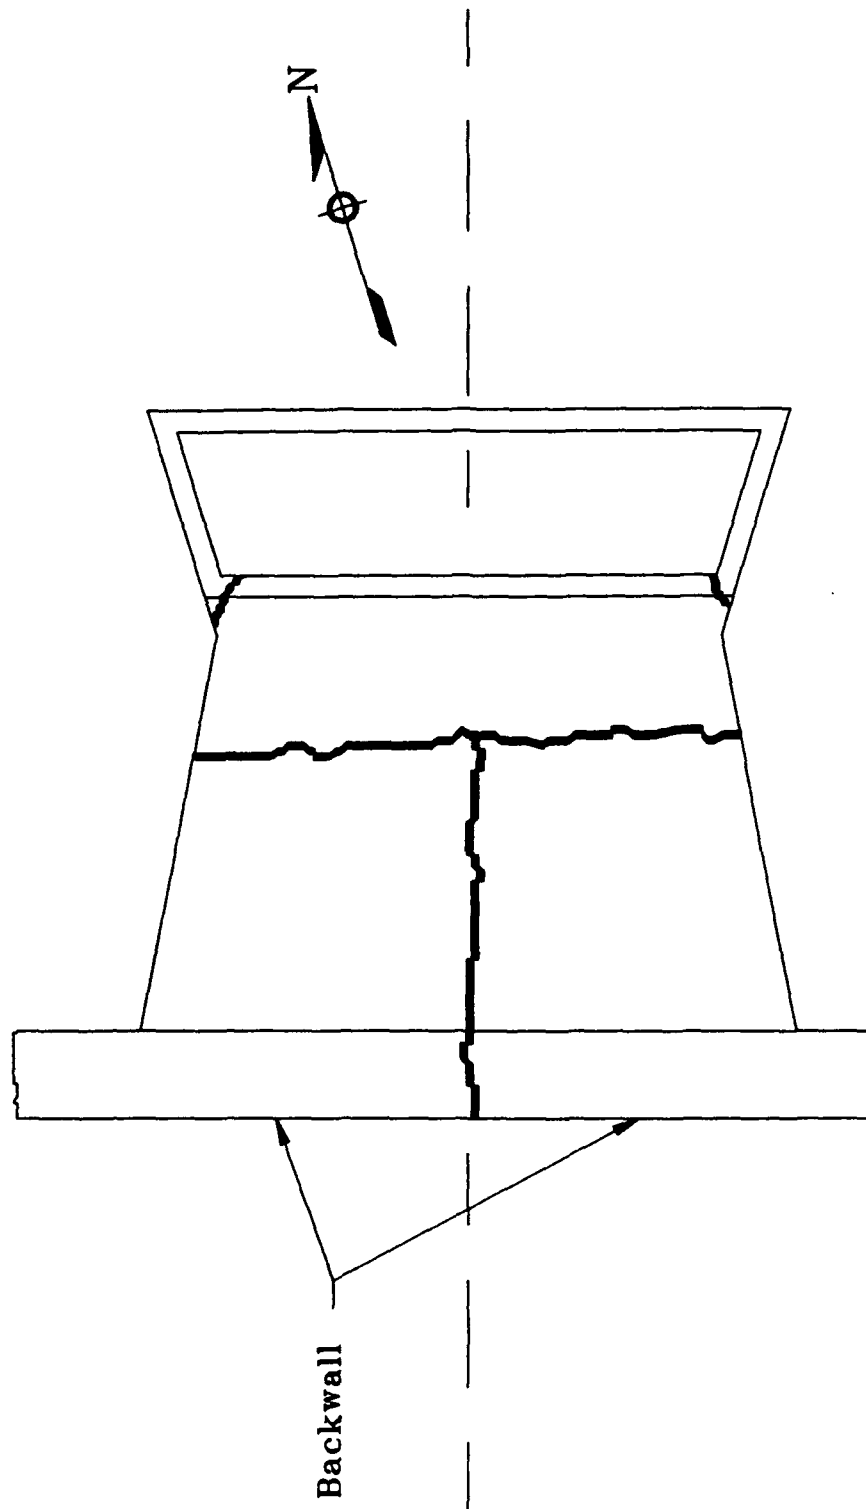
Figure 253. Plan: Breakup pattern of exhaust port roof, PAS-4.

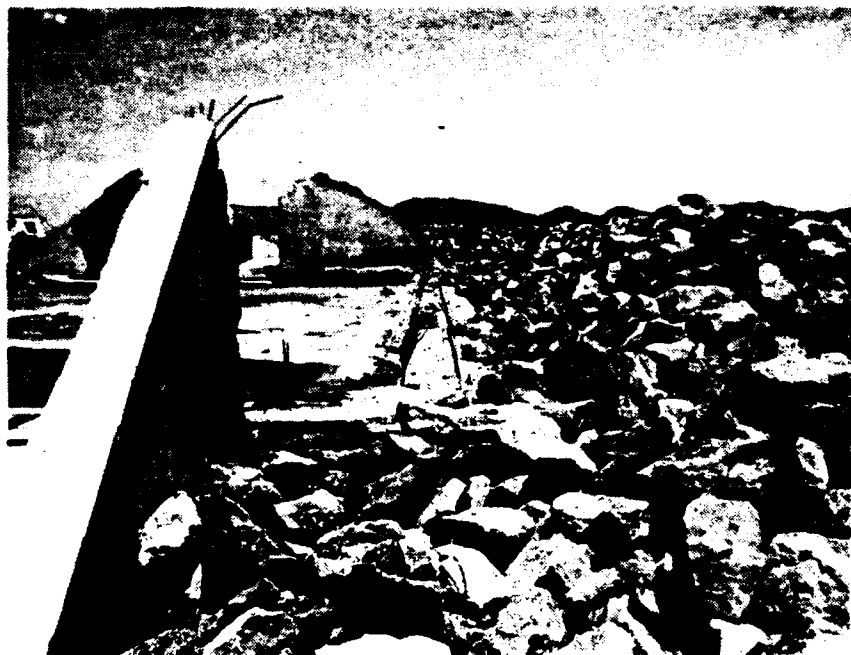
Figure 272. Posttest view of rock rubble berm adjacent to arch foundation, PAS-4.

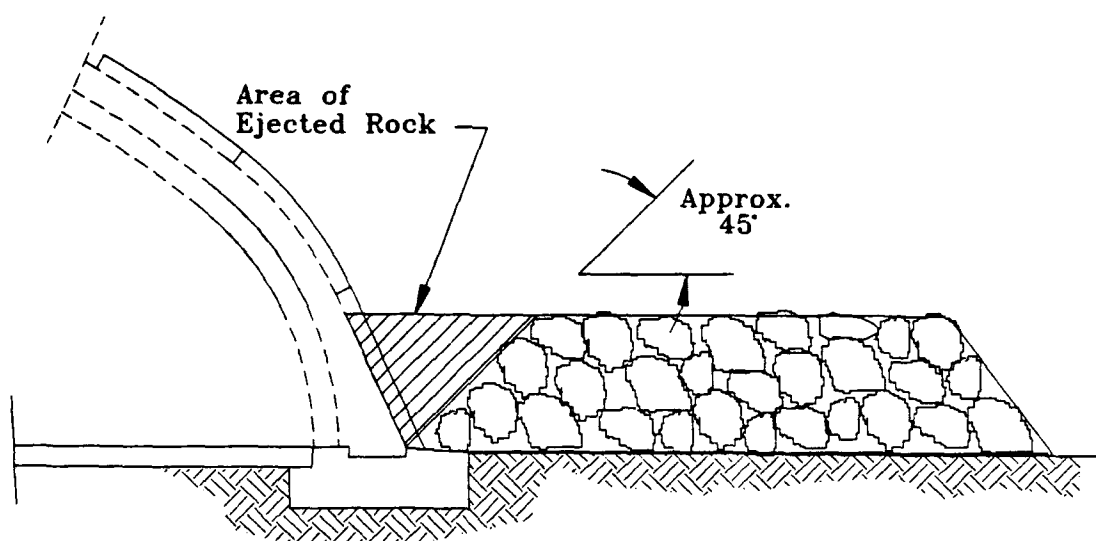
Figure 273. Portion of rock rubble berm ejected during test, PAS-4.
